A Cable Condition Monitoring Strategy For Safe And Reliable Plant Operation

Keywords— *cables, condition monitoring, aging assessments, remaining useful life*

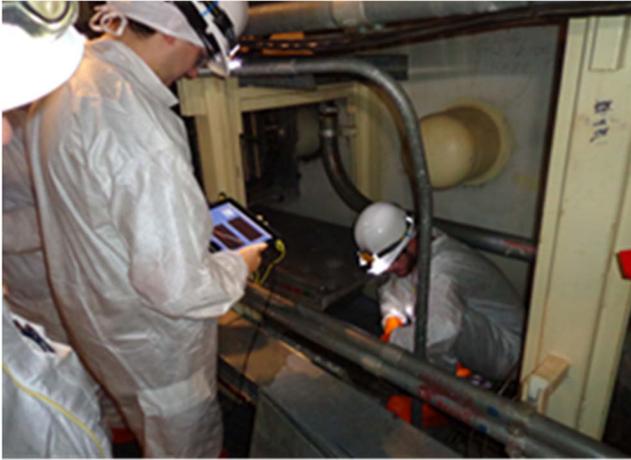
For this case study, indenter modulus (IM) testing was performed in-situ to assess the current condition of cables that have been in service at a nuclear power for over forty (40) years. Fig. 1 shows engineers performing IM testing of the cables included in the project. The results of this testing helped support the work being performed by the plant to pursue a subsequent license renewal for continued operation (i.e. 60 to 80 years). These cables are located in cable trays inside the reactor containment building, and during plant operation are exposed to

Fig. 1. Engineers Performing IM Testing of Cables Installed in Reactor Containment

The IM test is performed to measure and monitor changes in the hardness of cable insulation and jacket polymers as they age. It is a localized in-situ non-destructive mechanical test that is applied using a system that clamps around the cable under test and uses an instrumented probe that is pressed against a polymer to measure the localized hardness. The testing discussed here involved performing IM measurements on the jacket materials of ten (10) cables installed in reactor containment and using the data as a leading indicator of cable insulation degradation. IM data was also collected for the jacket materials of seven (7) cables that were harvested from a benign environment and never placed in service. The results of these tests were used as reference data for comparison to the cables installed in the harsh environment. Based on the information provided by the plant, each of these cables were manufactured by Boston Insulated Wire (BIW) and constructed with neoprene jacket polymers.

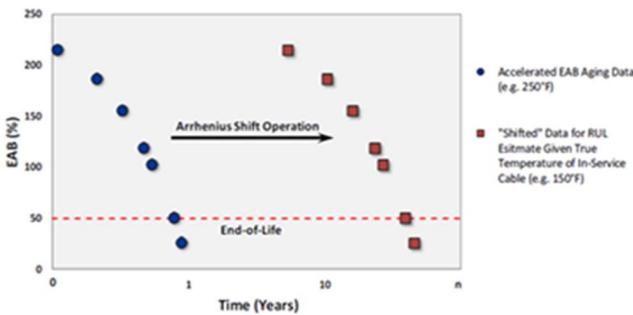
The RUL estimates for the insulation polymers were determined by applying the Arrhenius method to the accelerated aging EAB results for the cables and using the 50% absolute EAB end of life criteria to determine their end of life condition. Application of the Arrhenius method involves using the Arrhenius equation (1) to normalize EAB data taken during the accelerated aging process to the in-service temperatures of the cable. Fig. 2 illustrates how the Arrhenius method is applied to accelerated aging EAB data (blue trace) to normalize it to in-service environmental conditions (red trace).

Fig. 2. Example of RUL Estimation Using Accelerated Aging EAB Data

thermal accelerated aging normalized using the Arrhenius equation in- service temperature of the cable. Based on the results of the conservative end of life calculations performed during this work, the Pyrotrol III XLPE/O insulation polymer would have reached the end of life condition within the next 15 years, the Flamtrol insulation would have reached end of life in the next 5 years, and the Firewall III insulation polymer would not have reached the end of life condition during an extended period of operation (e.g. 60 to 80 years of service).
